**DEPARTMENT OF TRANSPORTATION**

Contract #: 04-0120F4Cty: SF/ALA Rte: 80 PM: 13.2/13.9File #: 69.28**WELDING INSPECTION REPORT****Resident Engineer:**Pursell, Gary**Address:** 333 Burma Road**City:** Oakland, CA 94607**Report No:** WIR-013119**Date Inspected:** 16-Apr-2010**Project Name:** SAS Superstructure**OSM Arrival Time:** 700**Prime Contractor:** American Bridge/Fluor Enterprises, a JV**OSM Departure Time:** 1900**Contractor:** Zhenhua Port Machinery Company, Ltd (ZPMC), Changxing Island **Location:** Shanghai, China

Incident Report for Segment 8AW (Floor Beam)

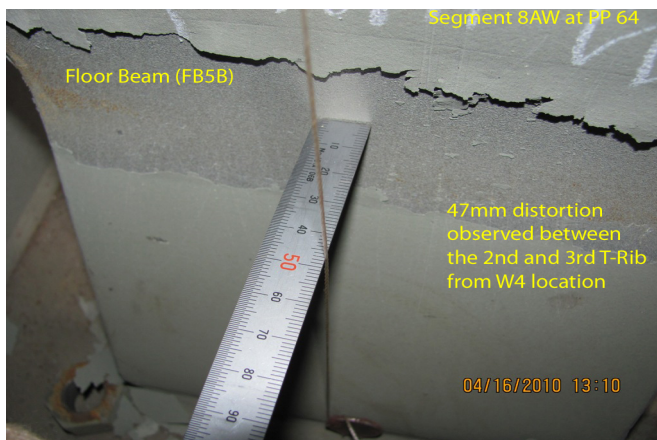
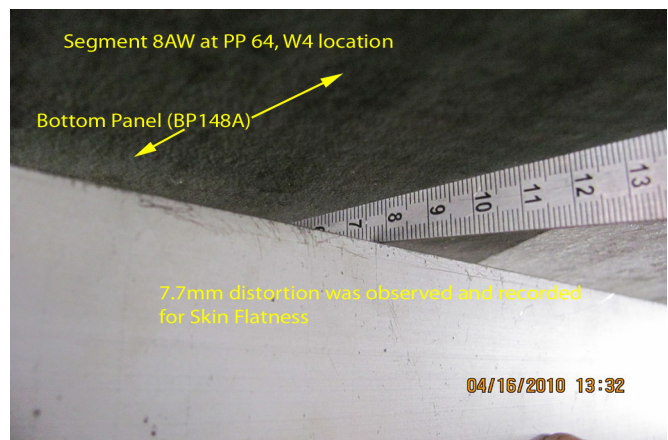
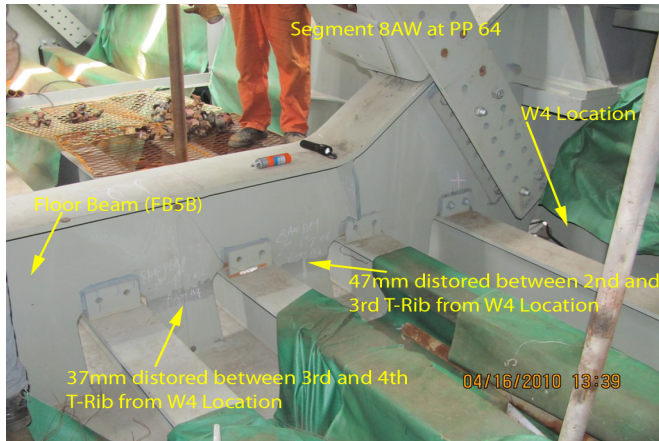
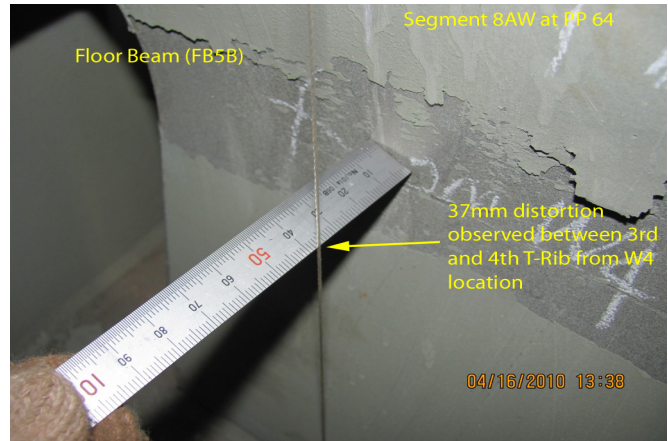
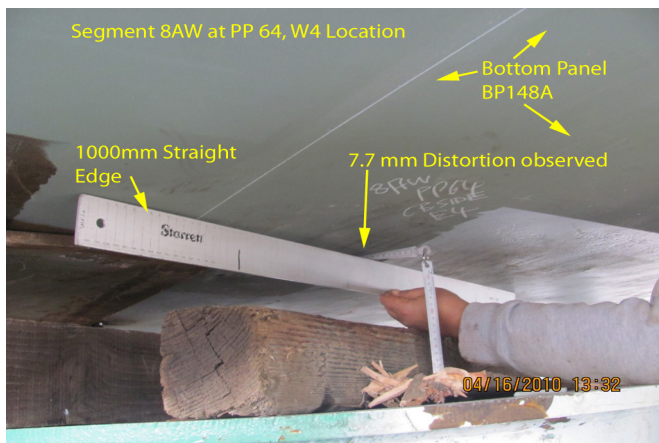
This Quality Assurance (QA) Inspector wrote an Incident Report for Deformation for Floor Beam and Bottom Panel for Segment 8AW at PP64 at W4 location for more comprehensive details please refer the Incident Report # 04-0120F4\_TL-15\_B278\_04-16-10\_8AW\_Distorted\_Floor Beam\_PP 64\_W4 Dated April 16, 2010. Please refer the pictures attached below for quick reference.
